The Effect of Wear on Fire-Blocking Layer Material Effectiveness

J. Michael Barrientos

January 1995
DOT/FAA/CT-TN94/16

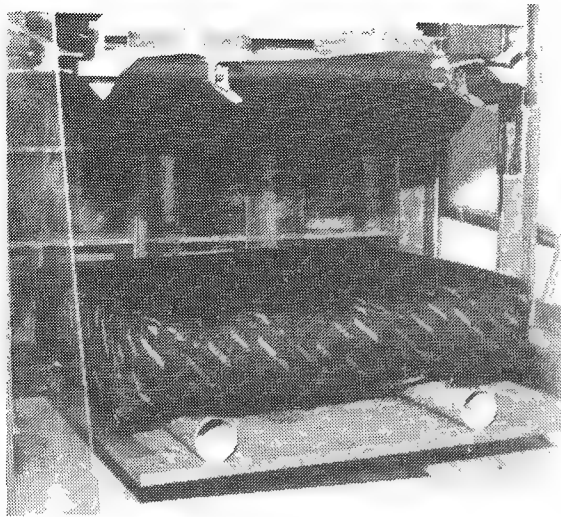
2-Minute Cycle
1-Minute 40-Seconds Contact on Cushion
20-Seconds in Up Position

FIGURE 2. BOEING'S "SQUIRMING HERMAN" TEST APPARATUS

Wear testing was conducted on Testori materials to determine if wear on fire-blocking layer material changes its protective properties. These tests were conducted by Weber Aircraft in Gainesville, Texas, on July 27, 1993, using the Support Standard BSS-7302, also known as the "Squirming Herman", developed by Boeing (figure 2). The wear tester apparatus consisted of a buttocks shaped block which was in contact with the seat at 140 pounds of pressure for 100 ± 2 seconds and withdrawn from the seat for 20 ± 2 seconds completing the 2-minute cycle. The buttocks portion of the test apparatus underwent a 12 degree arc rocking motion and operated at 13-14 cycles/minute; the cushion then went through a 38-degree arc rotation at a 19.5 cycles/minute rate.
